NASA TM X-1119

INVESTIGATION OF ATLAS SOLID
FUEL RETARDING ROCKET DURING
ATLAS-CENTAUR SEPARATION TESTS

*Lewis Research Center
Cleveland, Ohio*

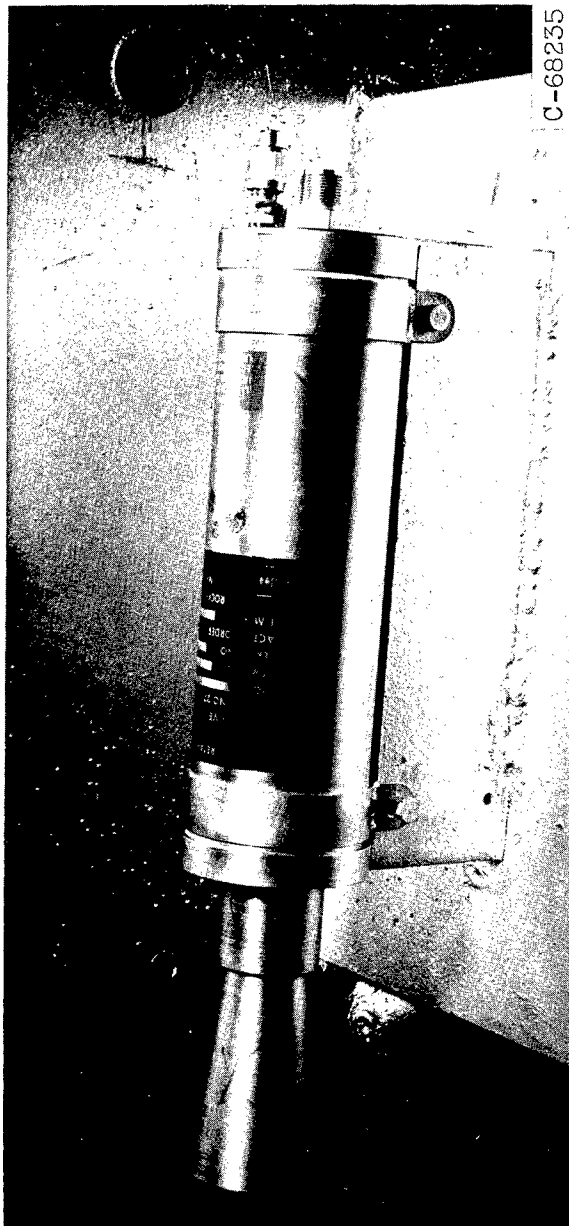
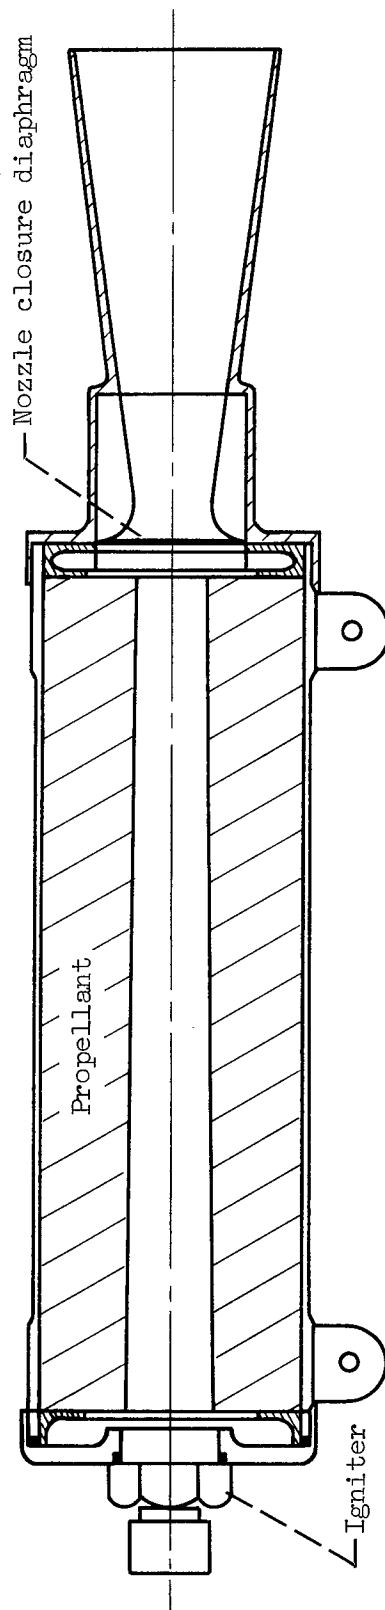
Figure 1. - Rocket tested: P/N 2547-11, Rocket Power, Inc.

The rocket tested (Rocket Power, Inc., P/N 2547-11) has a nominal total impulse of 500 pound-seconds and is 15.25 inches long and 2.75 inches in diameter (fig. 1). It is constructed with two removable end caps, one of which contains the igniter and the other of which is integral with the nozzle. A 0.040-

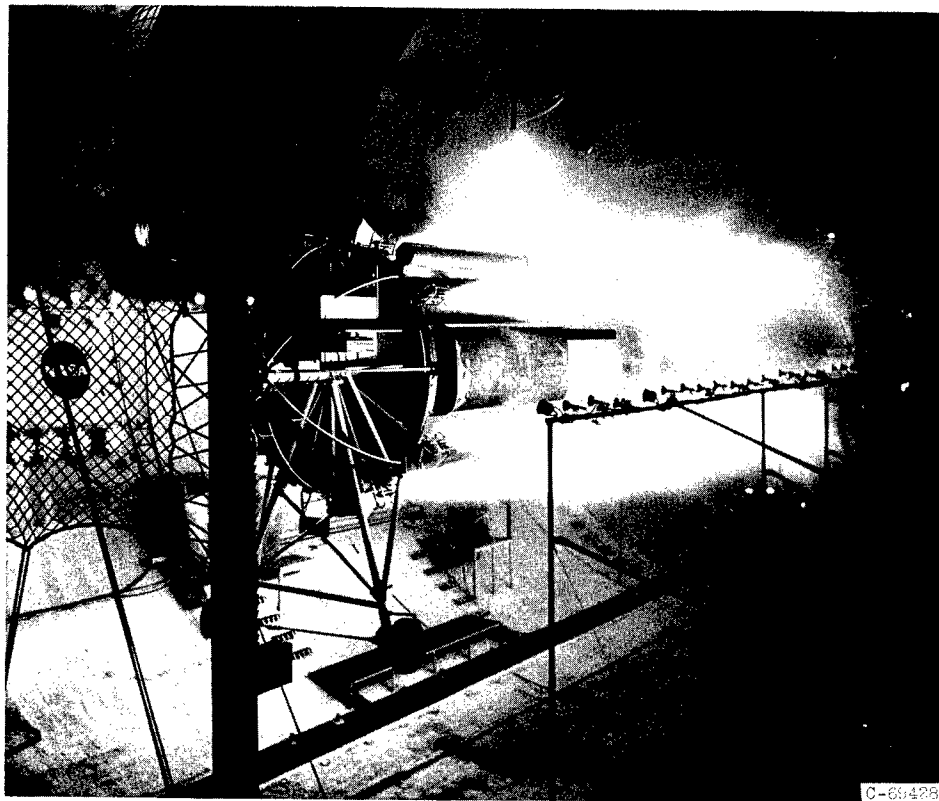
Figure 2. - Atlas model erected in Space Power Chamber.

Some of the data were obtained during the Atlas-Centaur separation tests. The eight rockets producing these data were mounted, as shown in figure 2, around the periphery of a full-scale Atlas model hung with its longitudinal axis horizontal. Additional data were obtained from rockets mounted on a small test stand and aimed down an adjoining chamber.

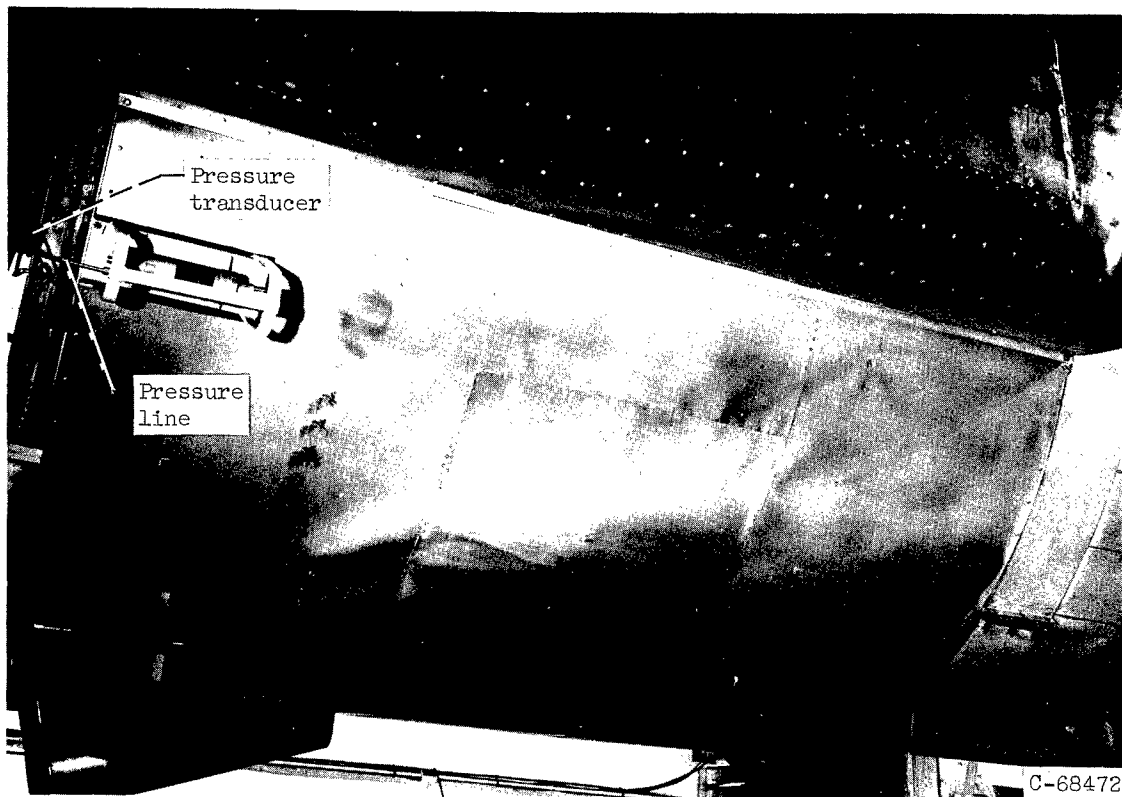
Figure 3. - Rocket and pressure sensing apparatus mounted on Atlas model.

Each rocket tested was modified to accept a fitting in the firing chamber cap at the igniter end. During the early tests, lines were run to strain-gage-type pressure transducers mounted on the Atlas framework (fig. 3). In later tests, the transducers were mounted below the pressure taps and suspended by silicone-oil-filled lines to reduce sensing errors, which could be incurred through the use of long air-filled lines, and to reduce the exposure of the transducers to heated combustion gases.
